## PROJECT BRIEF

### Remedy to Floor Slab due to Error in Placement of Reinforcement Bars at Wall Support with the TYFO® Fibrwrap® System

Housing Development  
in Kluang, Johor  
Malaysia  
January 2006

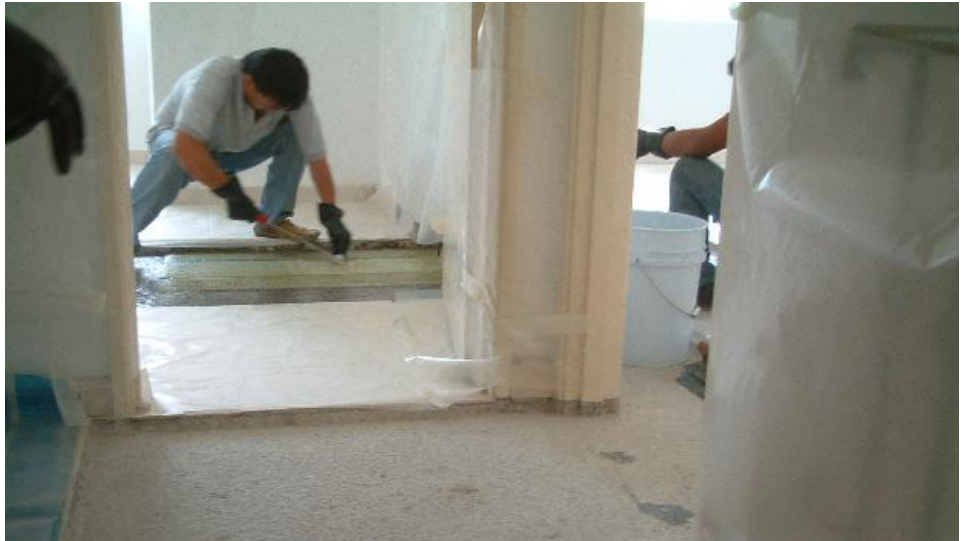
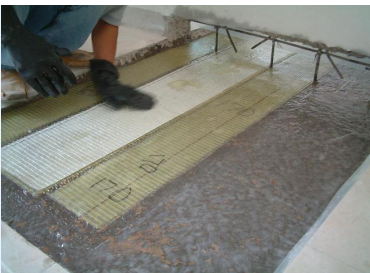
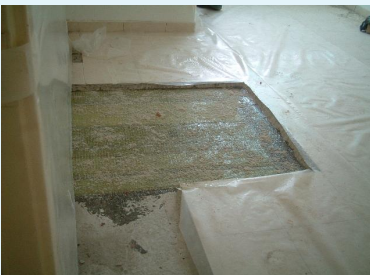
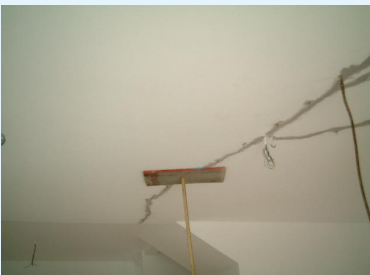
The new double storey terrace house was constructed using a shear wall-slab design system which is unique in that beams are replaced by wall support. The crack runs near the wall support, parallel to its longitudinal axis. It was found that the concrete cover to the top reinforcement mesh in the slab was too large – reducing the slab's ability in resisting bending near to the wall support. The presence of electrical conduits laid below at the bottom re-bar mesh layer also induces cracking due to its closeness to the bottom surface of the slab.

The above situation if not addressed would have caused the slab to leak as it was situated beside the common bathroom. The remedial measure proposed had to be sound to assure the property developer that the durability and integrity of the structure would be restored or enhanced back to its original intended state of design.

Due to its ease of installation, established track record, cost effectiveness and minimum disturbance to the finishes already installed, the TYFO® Fibrwrap® composite system became the preferable choice for the flexural strengthening. Cracks were grouted up prior to installation of the TYFO® SEH System.
