## PROJECT BRIEF

## Strengthening of Structurally Deficient Cement Silo with the TYFO® Fibrwrap® System

Taichung, Taiwan  
December 1999

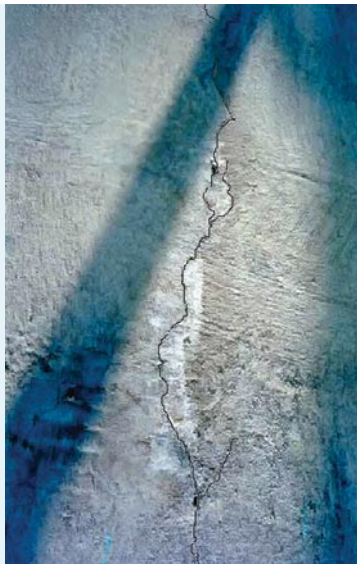
During routine maintenance inspection, the owner's structural engineers discovered vertical cracks spaced at regular intervals along the silo's outer walls. After conducting a more in-depth structural investigation, it was determined that the hoop reinforcement provided in the original design was inadequate to handle the high horizontal pressure exerted on the outer wall, in turn resulting in the vertical cracking seen at the outer tension face of the wall. Furthermore, due to the silo's proximity to the sea, corrosive elements such as salt and moisture from sea spray only worsened the situation.

A strengthening scheme using the TYFO® Fibrwrap® System was adopted to confine the entire structure, as the system was designed to replace the missing hoop reinforcement using a composite jacket of 1.3mm to 2.6mm thickness on the outer surface of the silo wall. The primary direction of the composite was applied in the circumferential direction with varying thickness in the vertical direction to cater to the change in horizontal forces acting on the silo wall with depth. As an added bonus, the composite jacket also contributed further to the protection of the existing concrete structure by providing an impermeable barrier to the corrosive environmental elements. The entire project from was successfully completed in about 3-and-half months' time.
