Tibet Cement Silo Structural Strengthening using TYFO® Fibrwrap® Systems

Lhasa, Tibet SAR
China
August 2006

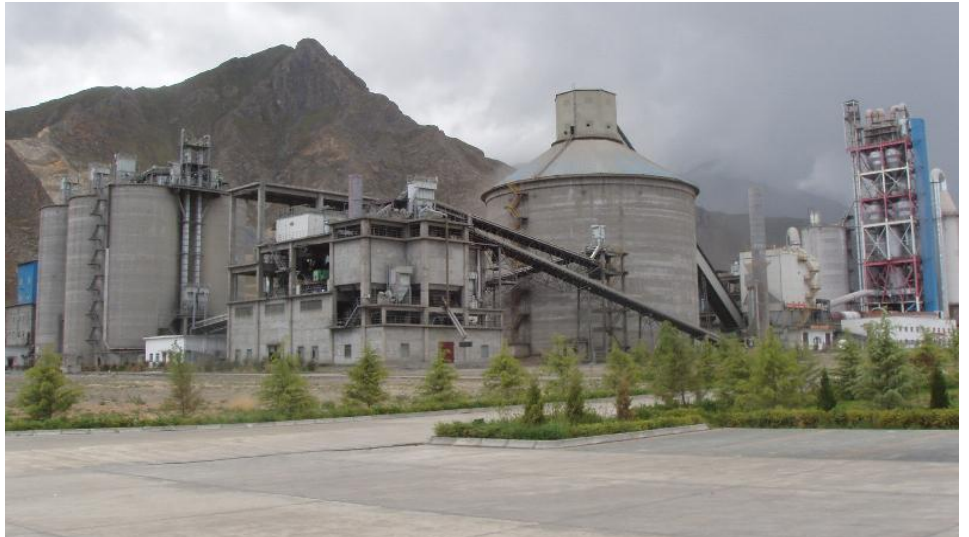
Located in the outskirts of Lhasa, capital of Tibet at an altitude of more than 4000 meters above sea level, a local cement production silo showed signs of cracks and severe concrete spalling. The reinforced concrete silo measured 44 meters high with an external diameter of 15.6 meters. After inspection and structural analysis, it was concluded that the silo was deficient in hoop reinforcement. This under design caused structural cracks running vertically in the mid section and the lower section of the silo. Other than structural design considerations, the silo's maximum internal operating temperature was 120 deg C with average temperatures of 100 deg C. Also, the high abrasive effect of the cement during discharge on the internal walls was another major consideration. Coupled together, it was postulated that these factors were the cause of the concrete deterioration leading to widespread spalling.

For the design calculations, the shortfall in hoop resistance was tabulated at various levels along the silo's height and compensated for by the TYFO® SEH51 Fibrwrap® System. A certain amount of over provision was necessary in consideration of the high operating temperature. An in-situ test was further proposed on a trial Fibrwrap® area to ensure that the System could withstand such high operating temperatures. As for abrasion, it was deemed that the bond strength of TYFO® S epoxy to a well prepared concrete substrate should be able to withstand the abrasion caused during the cement discharge.

During installation there were many difficulties and challenges to overcome. Work commencement had to be delayed as some of the workers suffered from acute altitude sickness and trucking of materials to the site location took longer than expected due to the remoteness of the site as well as the rough terrain en-route. Therefore safety was a prime consideration and sufficient rest was given to workers so as to ensure sound workmanship which was extremely critical since any under saturated composite or under primed surface would certainly delaminate under the silo's extreme operating conditions. The smallest delamination would choke the silo's discharge chute (which contains a sieve) and thus necessitate another costly shutdown to facilitate remedial works.

The in situ 100 - 120 deg C temperature test was performed and TYFO® SEH51 composite did not show the slightest visual or physical deterioration. The works proceeded smoothly from thereon and upon completion, it passed the engineer's first round of inspection and the silo was able to resume production on time.
