PROJECT BRIEF

Strengthening of Beams and Slabs of at Multipurpose Building with the TYFO® Fibrwrap® Composite System

Ampang, Malaysia
July 2005

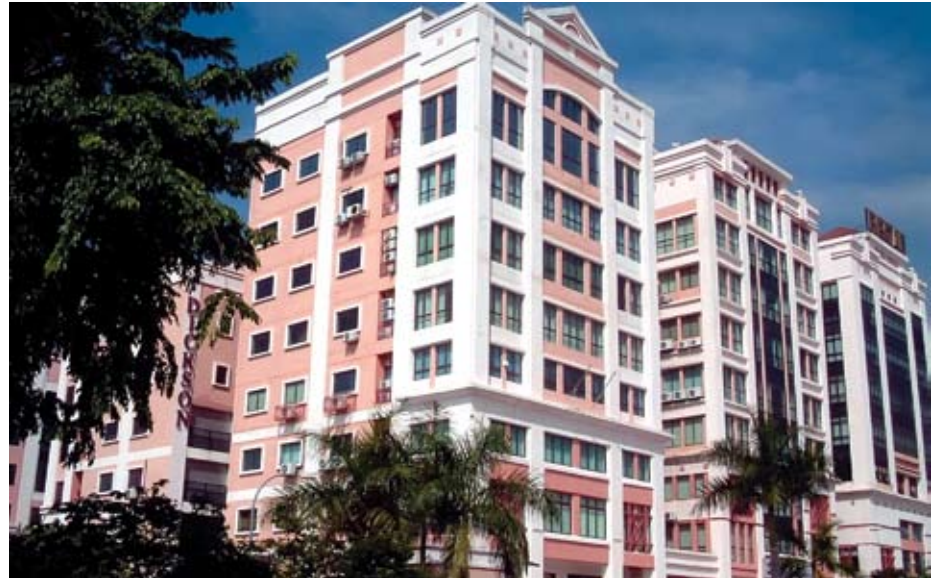
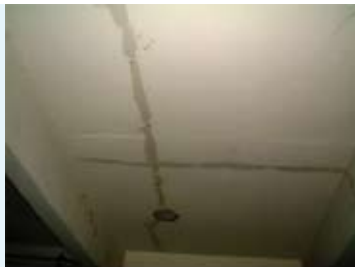
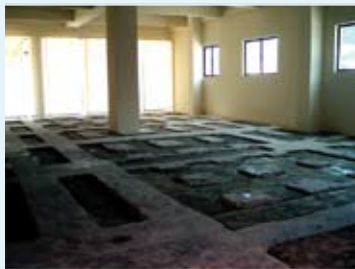
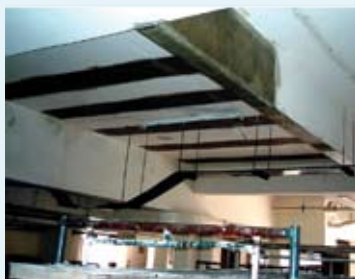
This relatively new commercial-plus-residential building in Ampang, Malaysia, showed signs of concrete distress in typical patterns on slab areas. A preliminary structural investigation was carried out in the affected portions to establish the cause of this cracking in the floor slabs and some beams. The cracks in the slab were found to co-incide with the location of service conduits embedded within the slab, affecting its load carrying capacity. Further investigation near cracked beams showed some areas with lower than designed concrete grade. Flexural capacity of the affected slabs and certain beams needed to be enhanced. Shear capacity of a few beams also required enhancement.

After grouting the redundant conduits and epoxy injecting the cracks on the floor slabs and beams, the TYFO® SEH51 Glass System was subsequently used to restore the structure to its intended load carrying capacity. The composite system was applied in strips to the top of the slab over supports to enhance negative movement capacity. Strips were applied at the soffit of slabs and beams for positive movement enhancement and on the sides of beams for beam shear enhancement.
