PROJECT BRIEF

Rehabilitation of Deteriorated Reinforced Concrete Water Reservoir with the TYFO® Fibrwrap® Composite System

Bogo Water District,
Cebu, Philippines
January 2005

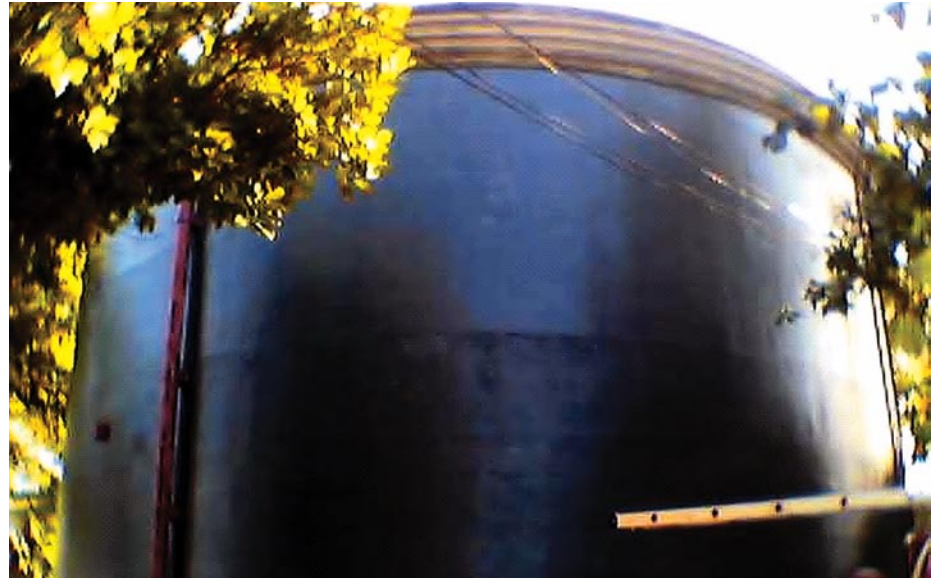
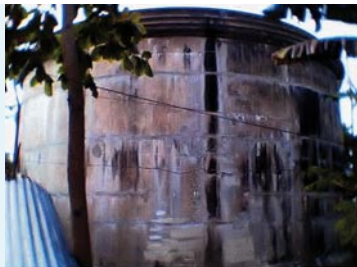
This aging 6000 m³ capacity reinforced concrete water tank located in the Bogo District of Cebu, Philippines, showed signs of severe concrete deterioration including leaks and corrosion of the internal reinforcement due to its extended service life. The Local Water Utilities Administration (LWUA) specified that the tank had to be preserved through rehabilitation of the external wall without affecting existing operating conditions.
